# 21150 PCI-to-PCI Bridge

Specification Update

*October 2001*

Order Number: [278258-009](#)

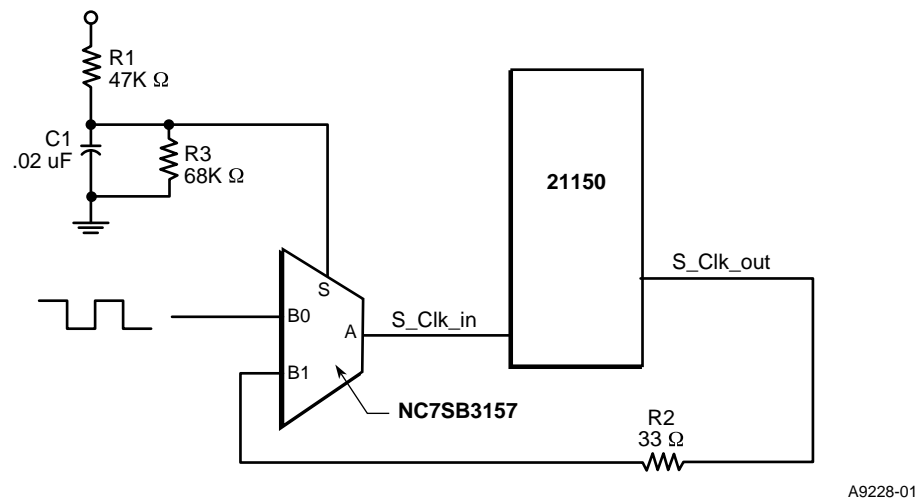
Figure 1. S\_Clock Multiplexer Workaround Circuit for Errata 6.

**Problem:** This problem has been found on the 21150AC and 21150BC. Under repeated and frequent power cycling, the secondary clock circuits may not power up in the proper state, resulting in the device not coming out of reset after power up.

**Implication:** In a system with a 21150AC or 21150BC that has one of its `s_clk_o <9:0>` outputs fed back to provide the `s_clk`, it is possible that the `s_clk_o <9:0>` output clocks will be driven and remain low, keeping `s_rst_l` asserted, during system power up.

This happens occasionally when a latch whose output disables the serial shift registers on the Secondary clock control powers up in a high state and the shift register bit corresponding to the `s_clk_o <9:0>` output that is fed back also powers up in the high state.

1. [Figure 1](#) illustrates the first recommendation - a circuit where an on-board pulse source is gated via the B0 input of the multiplexer to the `S_Clock_in` pin of the 21150.

At time 0, the S input of the multiplexer is low, allowing pulses from the on-board pulse source, connected to the B0 input, to be provided to the 21150 `S_Clk` input pin. When the time determined by the R/C network is satisfied, the S input pin will be in a logic High state. The Multiplexer will then shut off the input pulse from S0 and will direct the `S_Clock_out` pulses via the B1 multiplexer input, into `S_Clock_in`.

The values used for the R/C network should be selected to allow a minimum of 2 pulses to be delivered to the 21150 after V<sub>dd</sub> has reached 3.0V at a frequency not to exceed the appropriate PCI component. i.e. 30 ns for a 33Mhz bridge. These values should be chosen based on the rise time of the power supply and the frequency of the on board pulse source. The values given for R1, R3, and C1 are for example purposes only.

**Note:** The NC7SB3157 2:1 Multiplexer / Demultiplexer Bus Switch used in this example has a maximum propagation delay of 800ps that should be taken into consideration when matching trace lengths of the clock lines to avoid introducing excessive skew in the clocks. All S\_Clock etch lengths must be matched to within 2ns @ 33Mhz or 1ns @ 66Mhz. The addition of this circuit requires that the etch length for the S\_clock\_in signal be reduced to compensate for the 800ps delay.

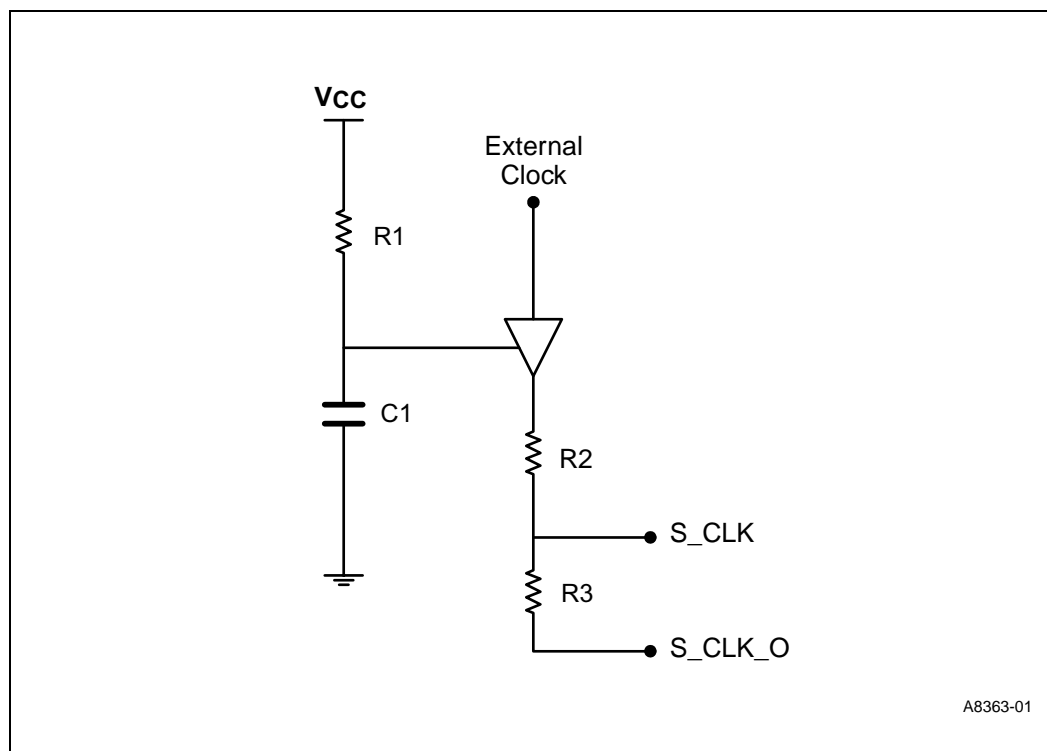
Figure 2. Recommended Circuit for a Tristable Buffer

3. In the third recommendation, to guarantee the proper initialization of the s\_clk circuits the addition of an external circuit that would provide a minimum of two transitions on the s\_clk input during the power-up ramp is necessary. This can be done using a solution that drives an external clock onto the s\_clk input while 3.3V V<sub>cc</sub> is ramping during power up.

Figure 2 illustrates the use of a tristable buffer to provide multiple pulses to the s\_clk input. The V<sub>cc</sub> ramp rate and R1,C1 time constant determine the duration and amplitude of the pulses generated during power up. The R2-R3 values are chosen based on applicable board etch impedance-matching requirements.

The following should be considered in calculating the R1,C1 time constant

- Make the time constant of the circuit as short as possible, while still ensuring that a minimum of two pulses are generated during the Vcc ramp.
- Phase delay between **s\_clk\_o** and the external clock should be minimized.
- Matching the external clock and **s\_clk\_o** frequencies to reduce contention.
- Laboratory experiments using **p\_clk** as the external clock and a R1C1 time constant between 40 and 60 percent of the Vcc ramp have been successful using this configuration. However the use of **p\_clk** as the external clock violates the PCI bus specification for loading of the primary clock.

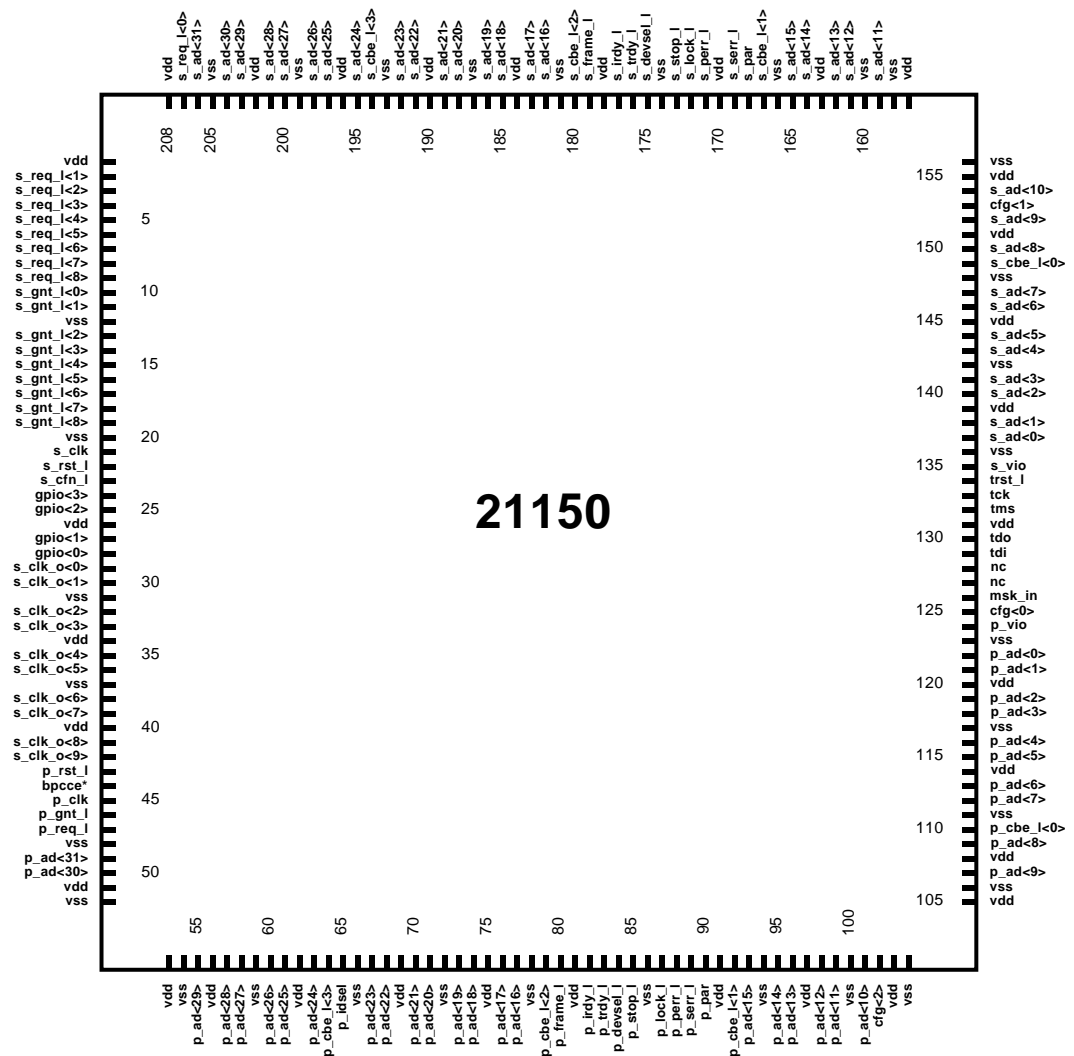
## 1. Section 3.0, Figure 5, 21150 Pin Assignment

Pin 44 should be designated bpcce\*. The following note should be added to the drawing: \*For 21150AB and later revisions only. This is a vss pin for the 21150AA.

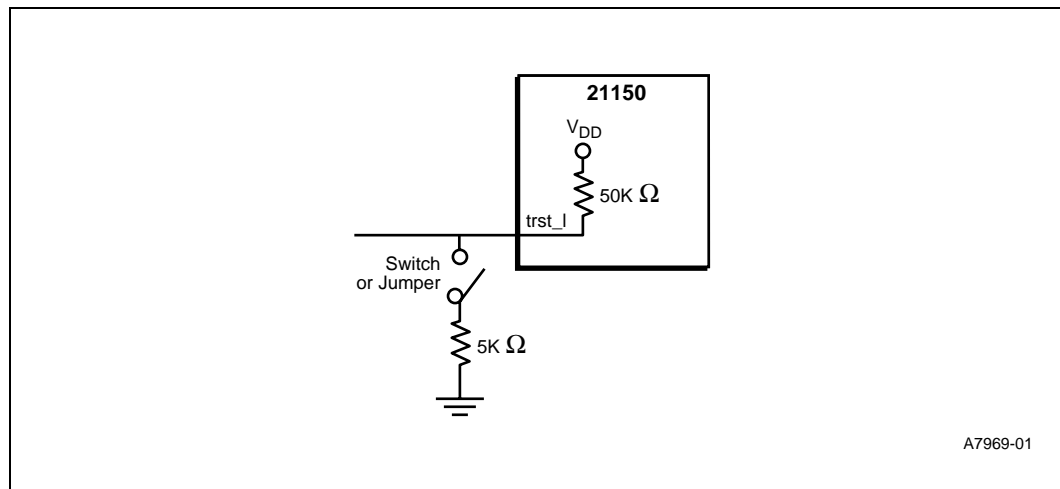
**Figure 2. Removal of pull-down resistor for JTAG testing**

A 5 K  $\Omega$  pull-down resistor is required on trst\_l for normal PCI-to-PCI bridge operation. However, some JTAG test results may be inconclusive if the 5 K  $\Omega$  resistor remains in the circuit. To obtain accurate JTAG results, Intel recommends one of the following solutions:

- Verify that the JTAG test equipment, after driving trst\_l low to reset the TAP controller, constantly drives trst\_l high during JTAG tests. If this signal is not constantly driven high, the 5 K  $\Omega$  resistor will pull the signal to a low state.
- Remove the 5 K  $\Omega$  resistor during JTAG tests. This resistor must be installed during normal PCI-to-PCI bridge operation.
- Design external circuits with a switch or jumper to isolate the 5 K  $\Omega$  resistor during JTAG tests (see [Figure 2](#)). This switch must enable the resistor during normal PCI-to-PCI bridge operation.
