21150 PCI-to-PCI Bridge

Specification Update

October 2001

Order Number: [278258-009](#)

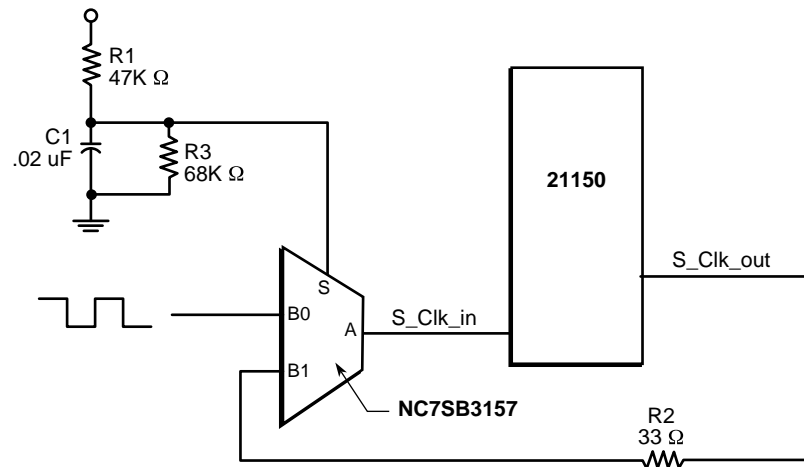
Figure 1. S_Clock Multiplexer Workaround Circuit for Errata 6.

Problem: This problem has been found on the 21150AC and 21150BC. Under repeated and frequent power cycling, the secondary clock circuits may not power up in the proper state, resulting in the device not coming out of reset after power up.

Implication: In a system with a 21150AC or 21150BC that has one of its `s_clk_o <9:0>` outputs fed back to provide the `s_clk`, it is possible that the `s_clk_o <9:0>` output clocks will be driven and remain low, keeping `s_rst_l` asserted, during system power up.

This happens occasionally when a latch whose output disables the serial shift registers on the Secondary clock control powers up in a high state and the shift register bit corresponding to the `s_clk_o <9:0>` output that is fed back also powers up in the high state.

1. [Figure 1](#) illustrates the first recommendation - a circuit where an on-board pulse source is gated via the B0 input of the multiplexer to the `S_Clock_in` pin of the 21150.

At time 0, the S input of the multiplexer is low, allowing pulses from the on-board pulse source, connected to the B0 input, to be provided to the 21150 `S_Clk` input pin. When the time determined by the R/C network is satisfied, the S input pin will be in a logic High state. The Multiplexer will then shut off the input pulse from S0 and will direct the `S_Clock_out` pulses via the B1 multiplexer input, into `S_Clock_in`.

The values used for the R/C network should be selected to allow a minimum of 2 pulses to be delivered to the 21150 after V_{dd} has reached 3.0V at a frequency not to exceed the appropriate PCI component. i.e. 30 ns for a 33Mhz bridge. These values should be chosen based on the rise time of the power supply and the frequency of the on board pulse source. The values given for R1, R3, and C1 are for example purposes only.

Note: The NC7SB3157 2:1 Multiplexer / Demultiplexer Bus Switch used in this example has a maximum propagation delay of 800ps that should be taken into consideration when matching trace lengths of the clock lines to avoid introducing excessive skew in the clocks. All S_Clock etch lengths must be matched to within 2ns @ 33Mhz or 1ns @ 66Mhz. The addition of this circuit requires that the etch length for the S_clock_in signal be reduced to compensate for the 800ps delay.

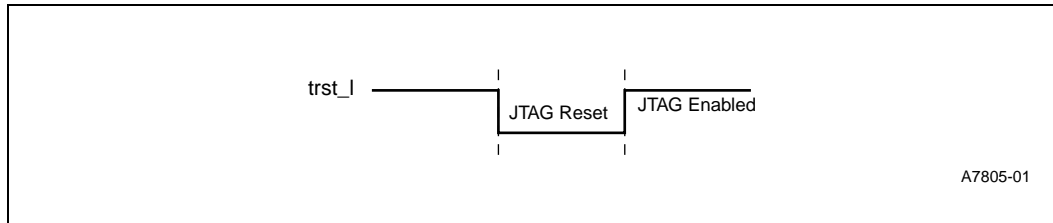
Figure 4. Signal trst_l States

The test access port controller and the instruction register output latches are initialized and JTAG is disabled while the trst_l input is asserted low (see [Figure 4](#)). While signal trst_l is low, the test access port controller enters the test-logic reset state. This results in the instruction register being reset which holds the bypass register instruction. During test-logic reset state, all JTAG test logic is disabled, and the device performs normal functions. The test access port controller leaves this state only after trst_l (low) goes high and an appropriate JTAG test operation sequence is sent on the tms and tck pins.

During normal 21150 operation the JTAG logic must be disabled by pulling trst_l low using a 5K resistor.

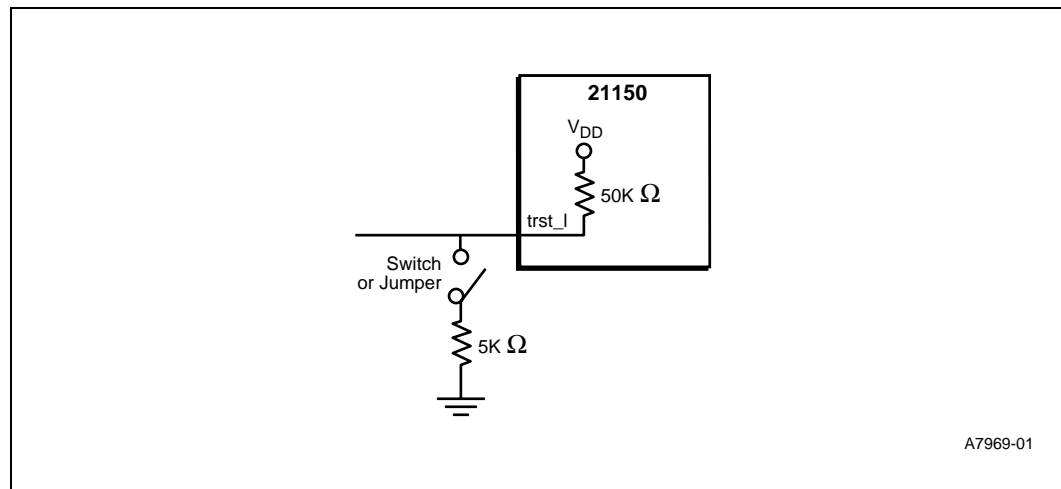
Figure 2. Removal of pull-down resistor for JTAG testing

A 5 K Ω pull-down resistor is required on `trst_l` for normal PCI-to-PCI bridge operation. However, some JTAG test results may be inconclusive if the 5 K Ω resistor remains in the circuit. To obtain accurate JTAG results, Intel recommends one of the following solutions:

- Verify that the JTAG test equipment, after driving `trst_l` low to reset the TAP controller, constantly drives `trst_l` high during JTAG tests. If this signal is not constantly driven high, the 5 K Ω resistor will pull the signal to a low state.
- Remove the 5 K Ω resistor during JTAG tests. This resistor must be installed during normal PCI-to-PCI bridge operation.
- Design external circuits with a switch or jumper to isolate the 5 K Ω resistor during JTAG tests (see Figure 2). This switch must enable the resistor during normal PCI-to-PCI bridge operation.
