21150 PCI-to-PCI Bridge

Specification Update

October 2001

Order Number: [278258-009](#)

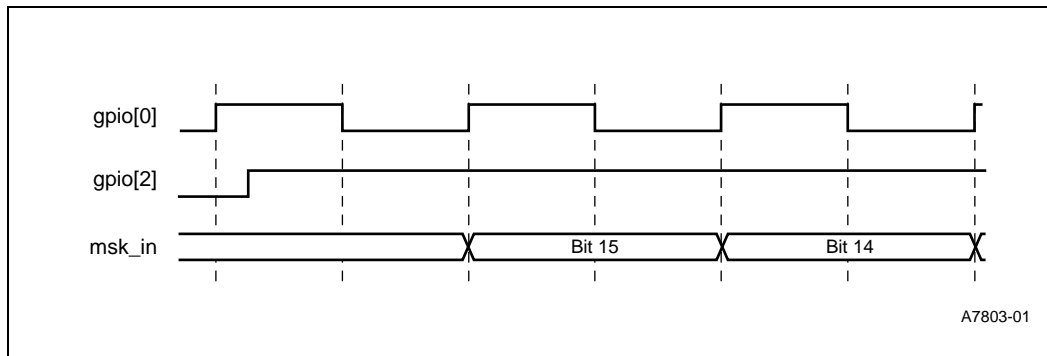
Figure 20. Clock Mask and Load Shift Timing

2. **Section 10.2, Secondary Clock Control, Figure 20**

This figure now appears as follows:

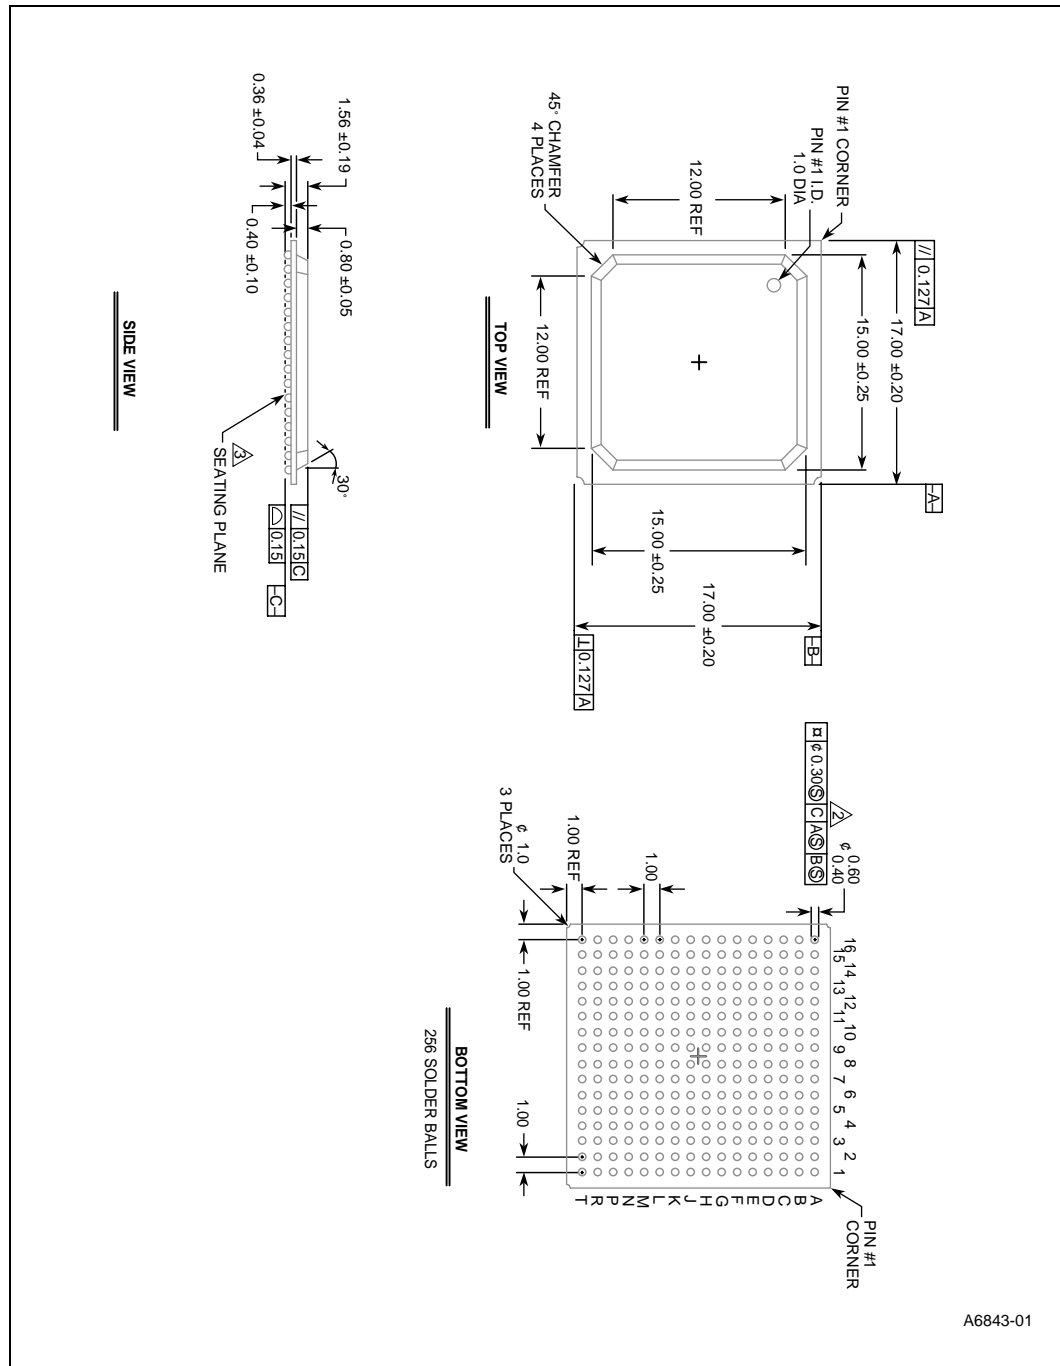
Figure 26. 21150 256 PBGA Mechanical Drawing

Figure 26 and Table 51 have been added to show that the 21150 also supports the 256 pin plastic ball grid array.

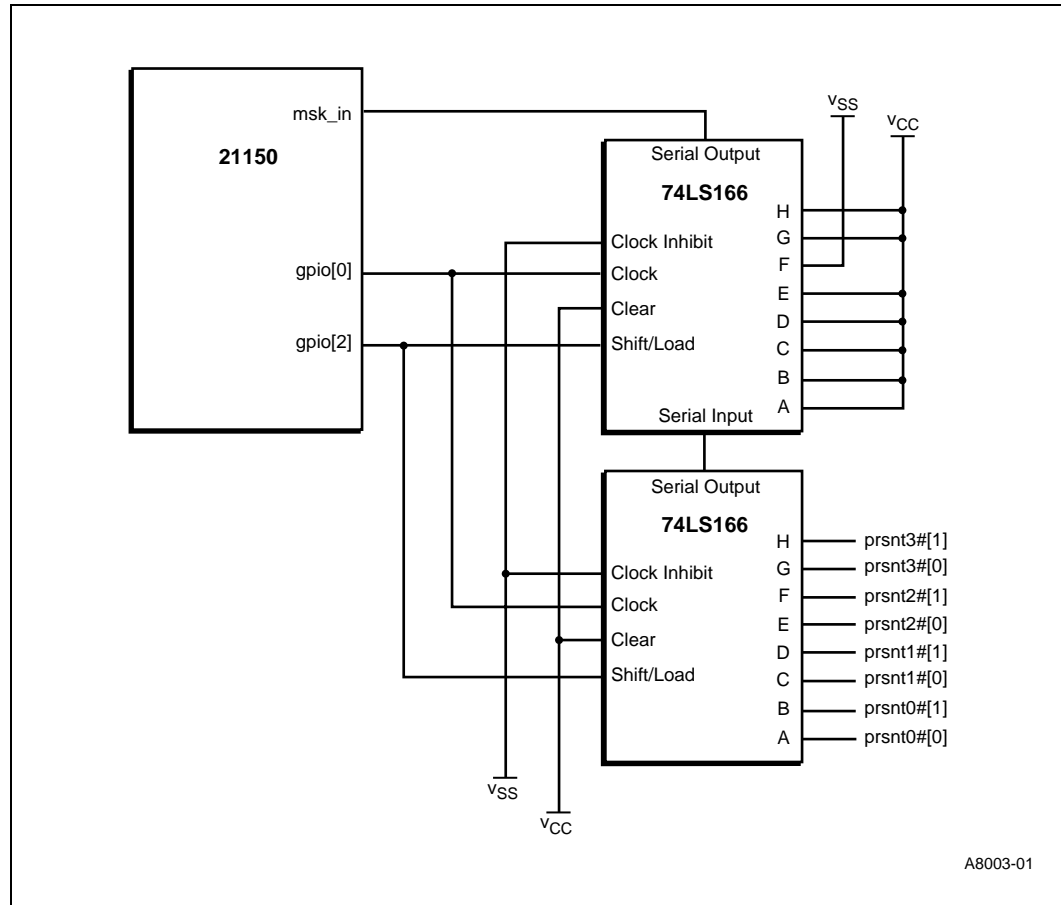
Figure 19. Example of gpio Clock Mask Implementation on the System Board

12. Section 10.2, Secondary Clock Control, Figure 19

This figure now appears as follows:
